## Flammability of Automotive Child Restraint Seats for Use in Aircraft

November 2001

DOT/FAA/AR-TN01/42

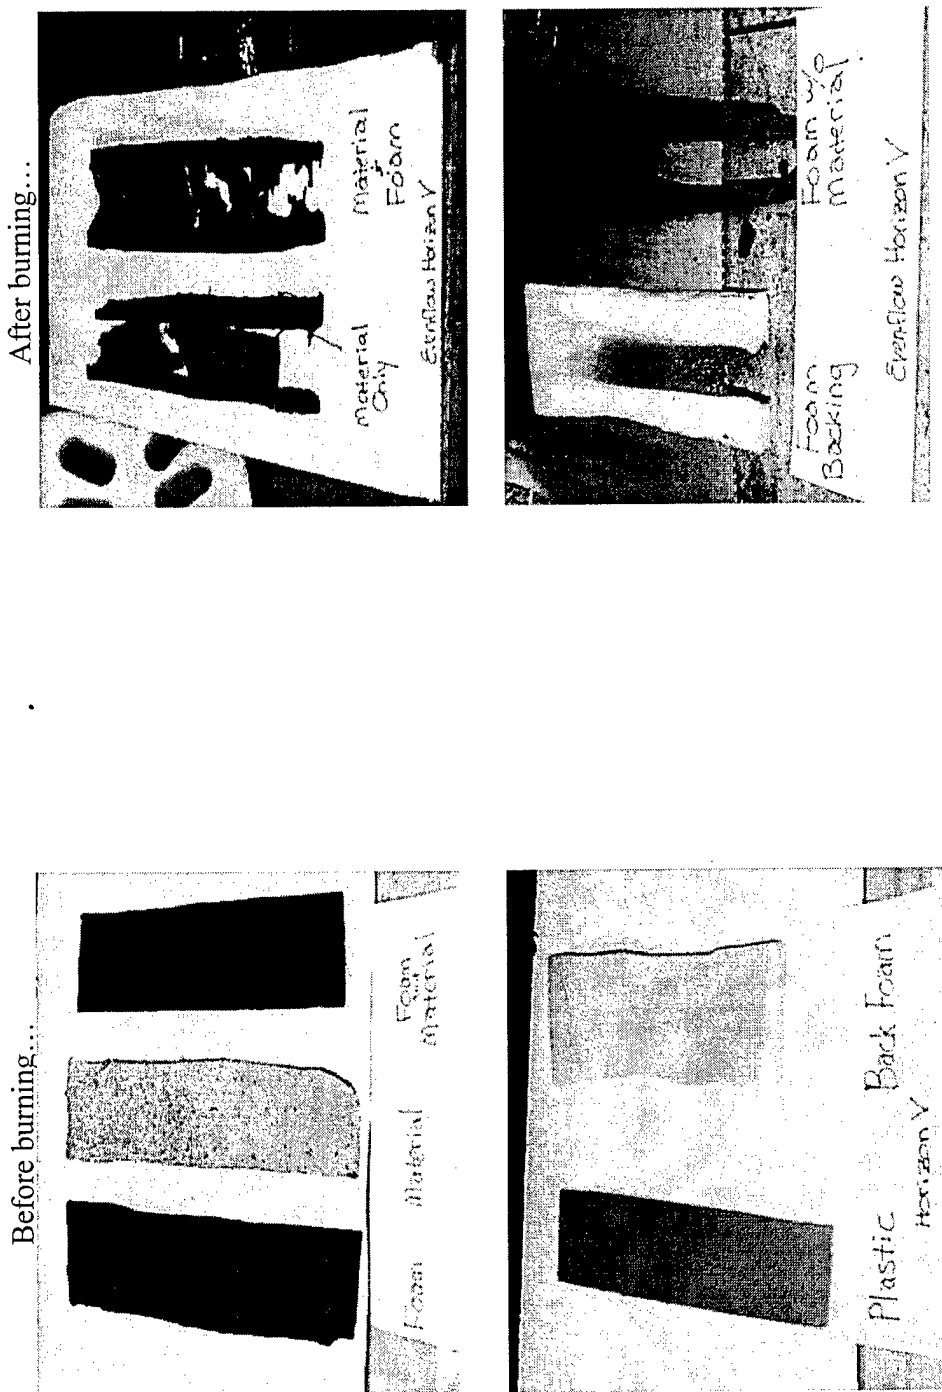
FIGURE 2. EVENFLO HORIZON V: \$79.99

- Evenflo Horizon V. Four of the five seat materials failed the vertical test criteria (figure 2). Three of the failed materials exceeded both the allowable flame time and burn length (entire sample length was burned).

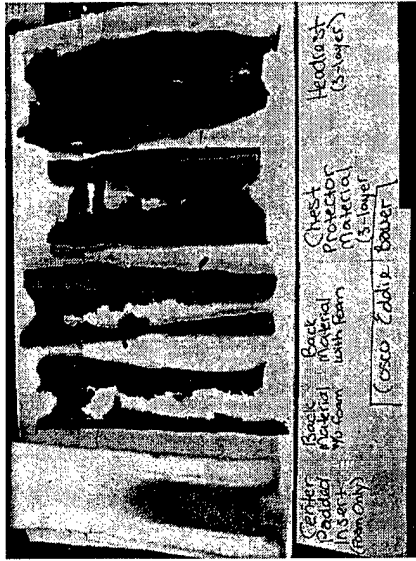
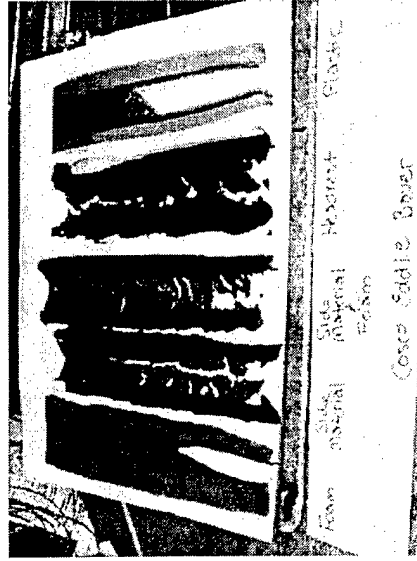
FIGURE 3. COSCO EDDIE BAUER: \$99.99

- Cosco Eddie Bauer. Seven of the eight materials failed the vertical test criteria (figure 3). All of the samples that failed exhibited very high flames. The center-padded insert foam, which passed, was the only material that did not exhibit high flames. One specimen of fabric material was tested in accordance with the FMVSS test procedure (horizontal orientation). A burn rate of 3.8 inches/minute was measured, just slightly less than the allowable 4.0-inches/minute value.

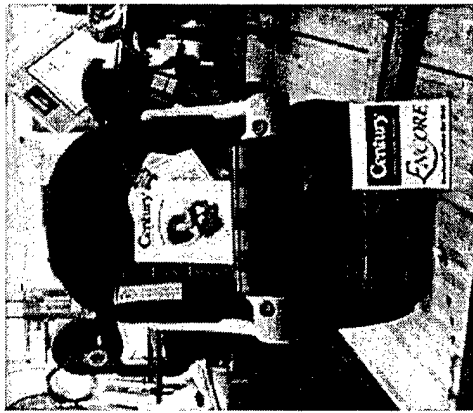
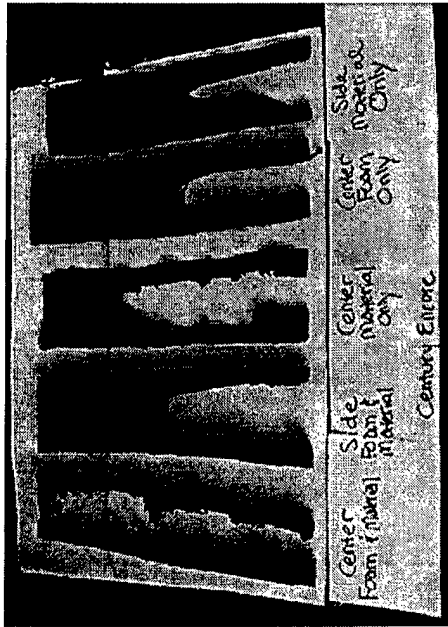
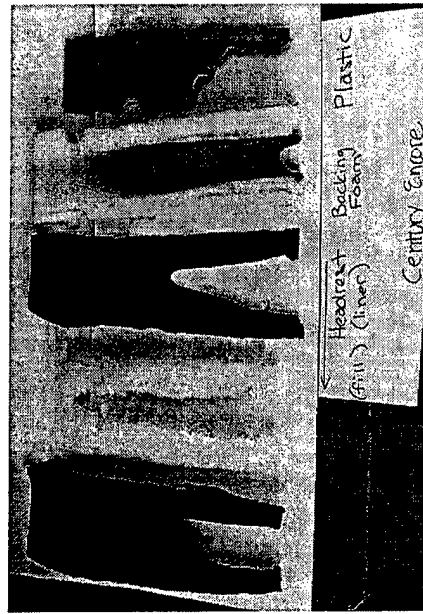
FIGURE 4. CENTURY ENCORE: \$89.00

- Century Encore. Four of the nine seat materials failed the vertical test criteria (figure 4). Some of the materials generated heavy smoke, including two of the samples that passed the test criteria. Again, even those samples that passed had relatively long burn lengths (>5 inches).

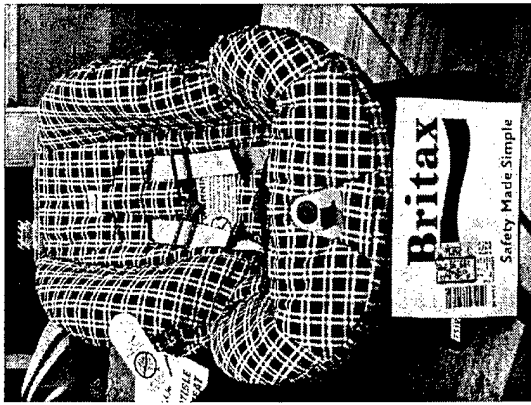
FIGURE 5. BRITAX TOTAL PLAID: \$199.99

- Britax (Total Plaid). Four of the seven seat materials failed the vertical test criteria (figure 5). Some of the materials, including a sample that passed, exhibited heavy smoke and, in one case, fast burning. The two materials that passed had relatively long burn lengths (>5 inches).

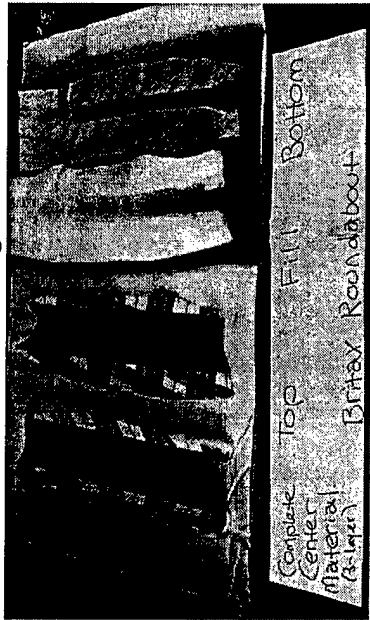
FIGURE 6. BRITAX ROUNDABOUT: \$199.00

- Britax Roundabout. Six of the eight seat materials failed the vertical test criteria (figure 6). Those materials that passed had relatively long burn lengths (7 and 8 inches). Four of the materials burned along the entire sample length.

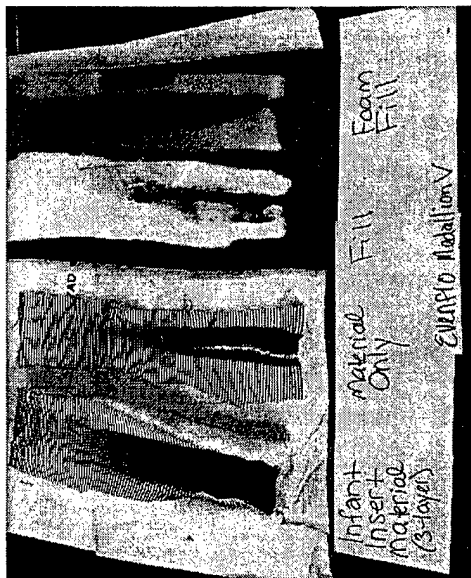
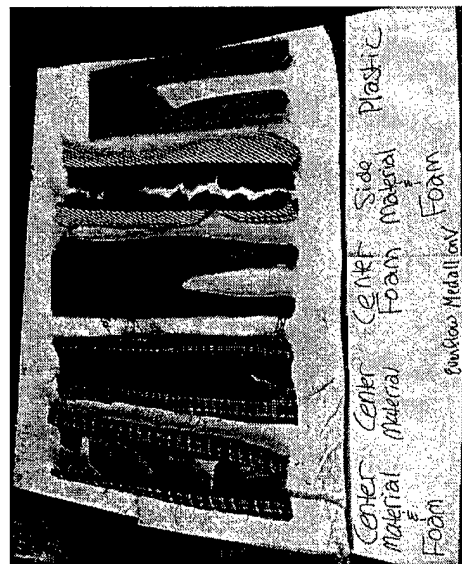
FIGURE 7. EVENFLO MEDALLION V: \$139.99

- Evenflow Medallion. Six of the nine seat materials failed the vertical test criteria (figure 7). The center material and foam produced the heaviest smoke of all seat materials in the

test series. It appeared that the dense smoke inside the test chamber was the cause of flame extinguishment. When it appeared that the flame was out and the door of the test cabinet was slightly opened to evacuate the smoke, the flame reignited apparently due to oxygen entering the cabinet.

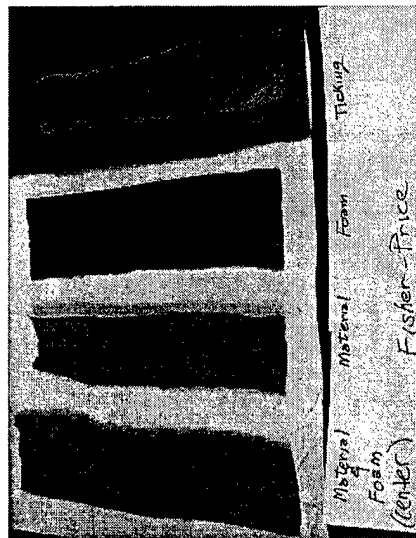
FIGURE 8. FISHER PRICE SAFE EMBRACE II: \$149.99

- Fisher Price Safe Embrace II. Three of the nine seat materials failed the vertical test criteria (figure 8). The materials that passed had relatively long burn lengths ( $\geq 5$  inches).
